Manhole Inspection Summary

Manhole # S39K__010MH

Insp Date: **12/30/08 9:30 AM**

Location Address: **fleet st**

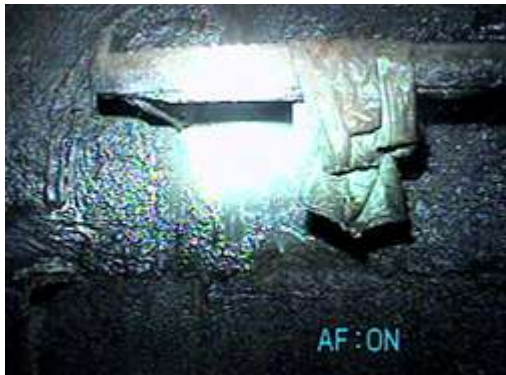
Defect 3

Surcharge ☒ Evidence Of Surcharge Depth: **11.** (ft.) ☐ Active Surcharge Present

evidence of surcharge

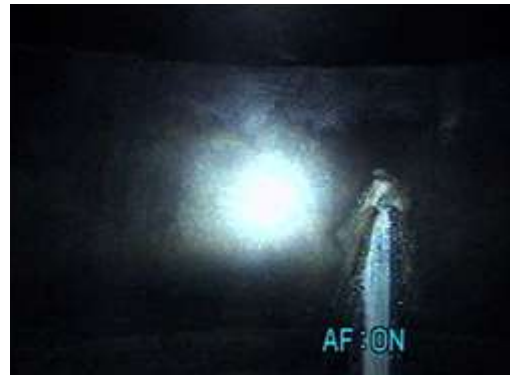
Defect 2

Infiltration: ☐ None ☒ Joint ☐ Cracks ☐ Mortar ☐ Roots ☐ Wall

infiltration in corbel

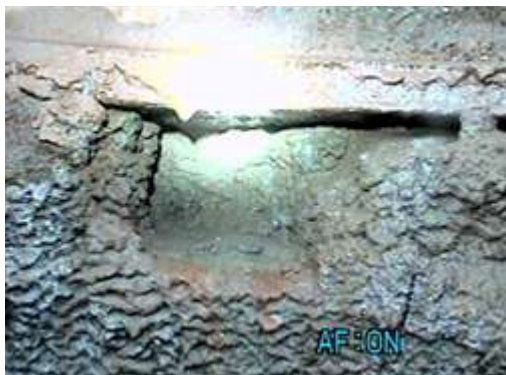
Defect 1

Condition: ☐ Sound ☐ Cracked ☐ Root Intrusion ☒ Loose Brick ☒ Deteriorated

Infiltration: ☐ None ☒ Joint ☐ Cracks ☐ Mortar ☐ Roots ☐ Wall

chimney loose bricks, deteriorated with infiltration from joint
